PRELIMINARY INSPECTION FOR MAYFLOWER PRIMARY SCHOOL (HOLDING)

6 Ang Mo Kio Avenue 2,
Singapore 569948

(Preliminary Inspection Report)

Date: 16th December 2021

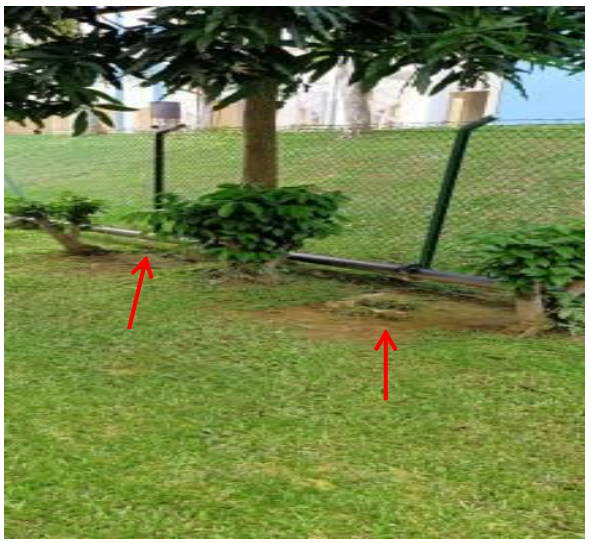
Location: Interceptor drain at walkway near to guardhouse

1) Spotted stagnant water in the drain due to uneven drain gradient. No active mosquito larva was found during the time of inspection.
2) Advised to rectify the uneven gradient for preventive measures.

Remarks: Inspection for all pests at surrounding premise. Found 02 bald spots on grass patch at fencing behind canteen which can collect water during heavy rain. Found stagnant water in interceptor drain at walkway near guardhouse due to uneven gradient.

Observation / Recommendations : Advise to repair soil on bald patches and to even up drain at interceptor.
