PRELIMINARY INSPECTION FOR AHMAD IBRAHIM PRIMARY SCHOOL

(Preliminary Inspection Report)

Date: 23rd December 2021

Service Report Series Number: 69626

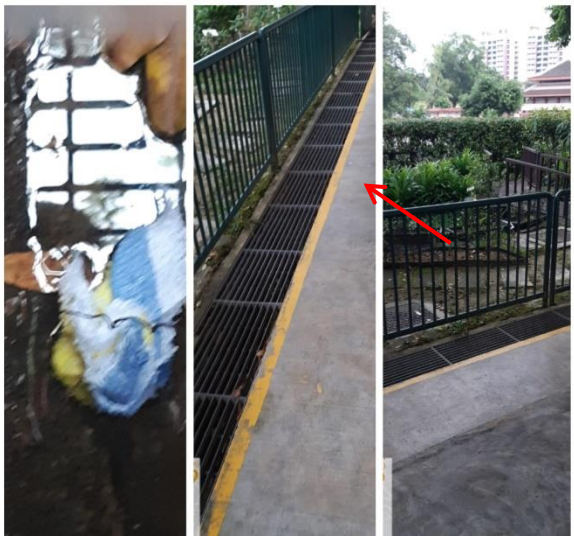
Location: Side entrance area

1) Spotted choked drain that filled with soil that might become potential mosquitoes breeding. No active larva was found during the inspection.
2) Advised to clean up the drain on a regular basis for preventive measure.
