Pest Control Service Report Summary

Messr	**Si Ling Pri Sch**	**Service Sheet No.**	**152670**
Area		**Date**	**2022-12-01**
Periodic Task		**Time In**	**13:35**
		Time Out	**14:20**

Location
☑ Si Ling Primary School

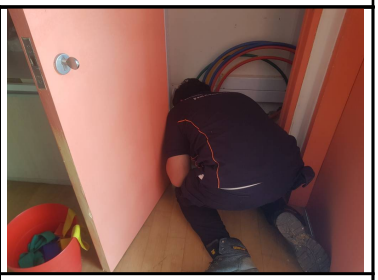
Remarks	**Inspection and treatment done at the above mentioned location.No mosquito activity found at the time of service.Ref to PAL room 4th floor found active termite and trail in the electrical riser floor.Installed termite baiting station to trap the termite.Follow up next 14 days.**
