PRELIMINARY INSPECTION FOR JIEMEN PRIMARY SCHOOL

(Preliminary Inspection Report)

Date: 24th December 2021

Service Report Series Number: 69639

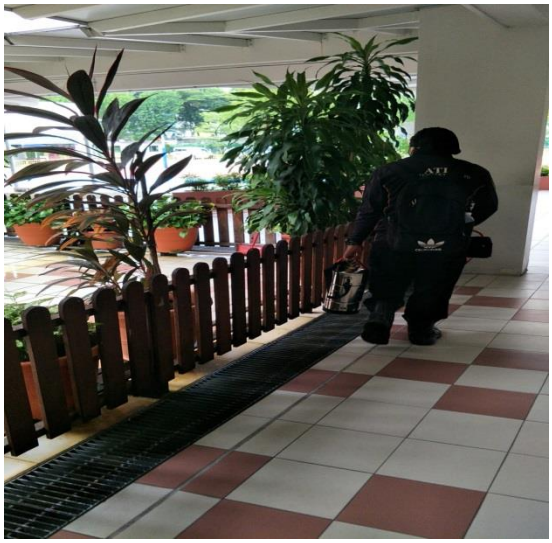
Location: Near bicycle parking garage

1) Spotted stagnant water that might become potential mosquitoes breeding.
2) Kindly maintain well the drains for preventive measures.

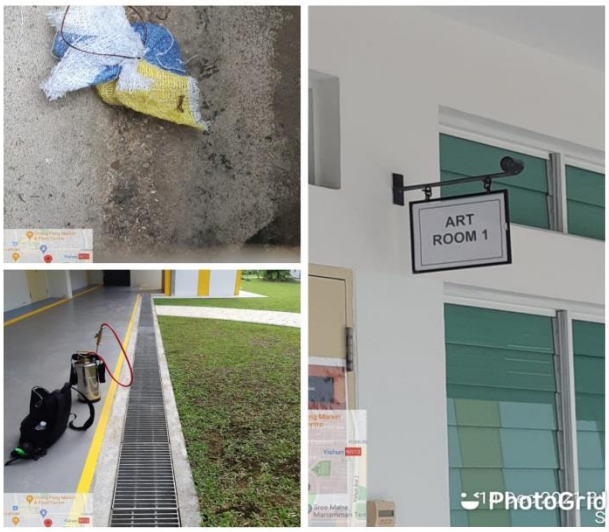
Location: Near guard room

1) Spotted stagnant water at the tree hole that might become potential mosquitoes breeding. No active larva was found during the inspection.
2) Advised to keep good housekeeping on a regular basis for preventive measure.
