Ministry of Education SINGAPORE

Pest Control Service Report Summary

Messr	**S/R Ahmad Ibrahim Secondary School**	**Service Sheet No.**	**134154**
Area		**Date**	**2022-10-03**
Periodic Task		**Time In**	**07:45**
		Time Out	**08:25**

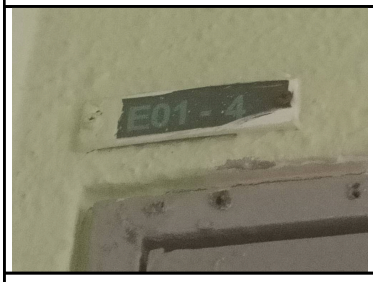
Inspection carried out to the above mentioned location.
Abate granules applied to all service and perimeter drains for prevention of mosquito breeding.
Attended ants feedback for Block E classroom 01-04..Light ants activities detected at window area..Gel treatment carried out..Will monitor and follow up during next routine service
No signs of active termites detected during time of inspection.

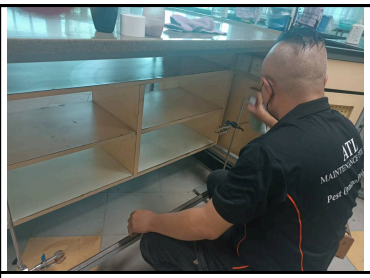
Remarks **Inspection carried out to the above mentioned location.**
Abate granules applied to all service and perimeter drains for prevention of mosquito breeding.
Drywood termites activities detected at Level 4,Science Lab 2..Dusting treatment carried out accordingly,will monitor and follow up during next service.
