PRELIMINARY INSPECTION FOR NORTHLAND SECONDARY SCHOOL

(Preliminary Inspection Report)

Date: 23rd December 2021

Service Report Series Number: 69620

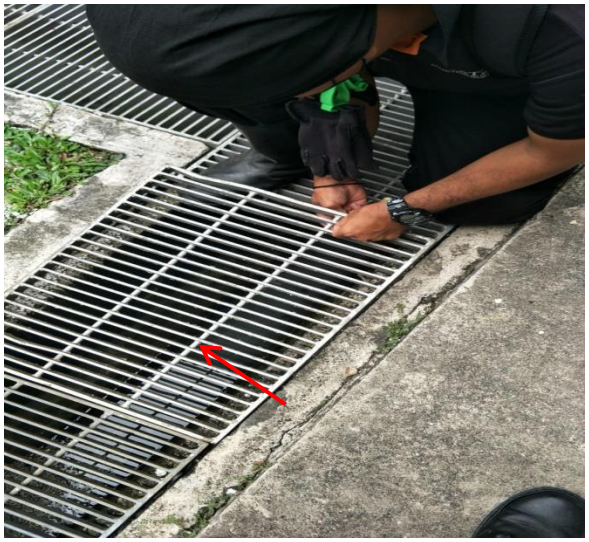
Location: Co axil distribution room area

1) Spotted choked drain that filled with soil that might become potential mosquitoes breeding. No active larva was found during the inspection.
2) Advised to clean up the drain on a regular basis for preventive measure.

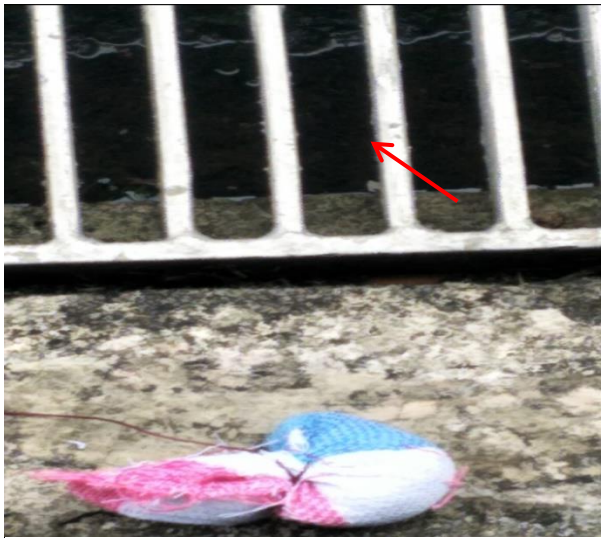
Location: Building N 2935-01

1) Spotted choked drain that filled with soil that might become potential mosquitoes breeding. No active larva was found during the inspection.
2) Advised to clean up the drain on a regular basis for preventive measure.
