Pest Control Service Report Summary

Messr	**Fuchun Secondary School**	**Service Sheet No.**	**124429**
Area		**Date**	**2022-09-01**
Periodic Task		**Time In**	**08:30**
		Time Out	**09:15**

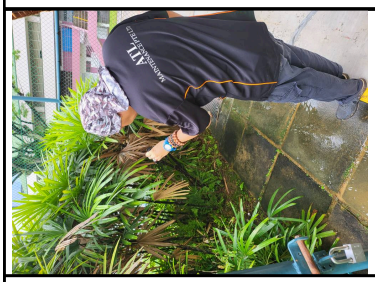
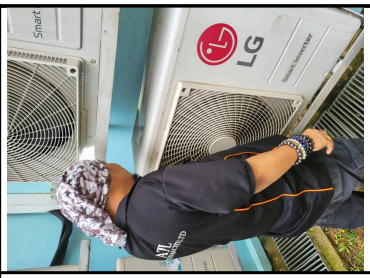
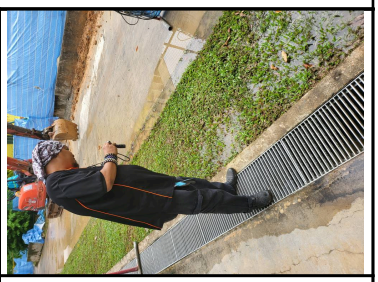
Remarks **Carried out inspection, treatment, search and destroy @ entire school. No sign of s/termite & MOSQ breeding was observed during the time of inspection. (Raining drizzling)**

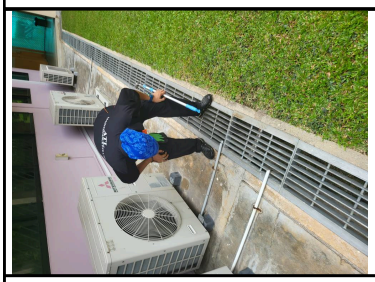
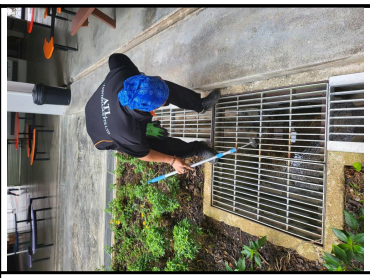
Remarks **Carried out inspection, treatment, search and destroy @ entire school. No sign of s/termite & MOSQ breeding was observed during the time of inspection.**

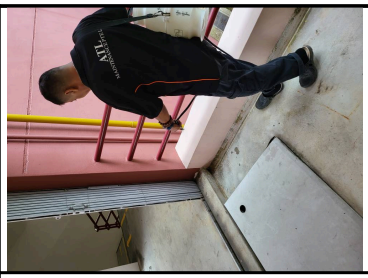
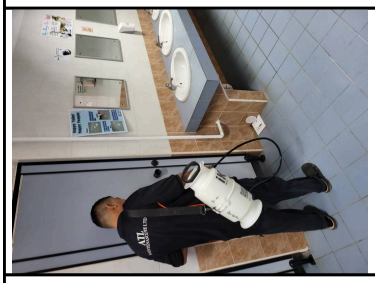
Remarks **Carried out inspection, treatment, search and destroy @ internal school due to heavy rain. No sign of s/termite & MOSQ breeding was observed during the time of inspection.**

Ants: Ants & Ants nest at Level 2 staircase 4 Destroy.
Rodent: No Rodent was found at cage n glueboard round the school.
Drywood Termite: Near GO. There still sign of activity found. Treatment done.

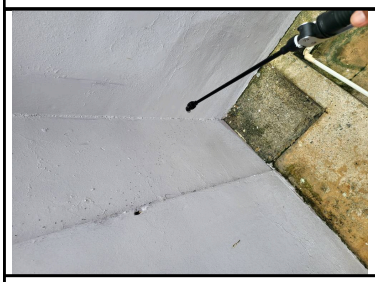
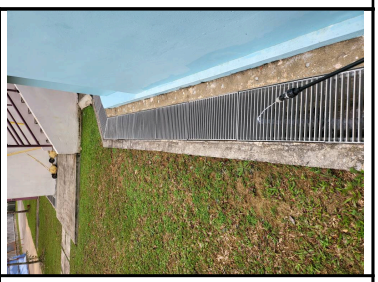
Ants at Bin centre and Blk B near D&T.

Uneven gradient in drain need to be improvised for better smooth of water flowing.

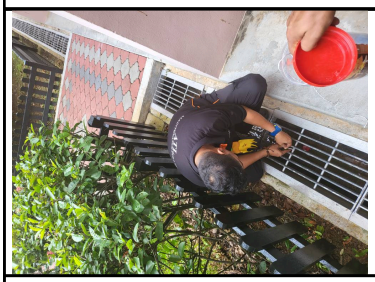
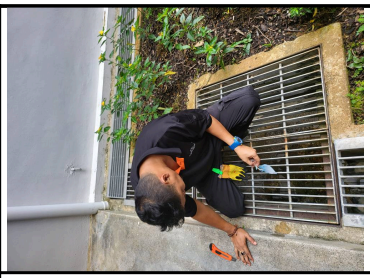
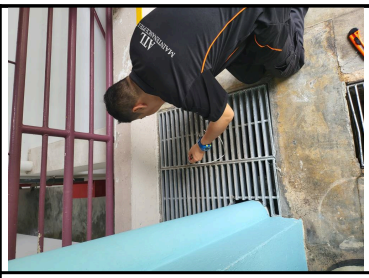
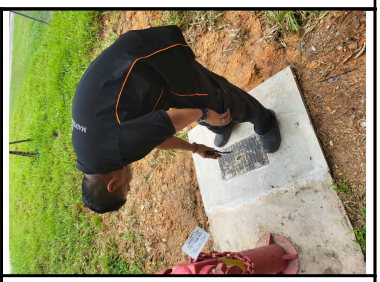
Remarks **Carried out inspection, treatment, search and destroy @ entire school. No sign of s/termite & MOSQ breeding was observed during the time of inspection.**

Feedback: Uneven gradient in drain need to be improvised for better smooth of water flowing.

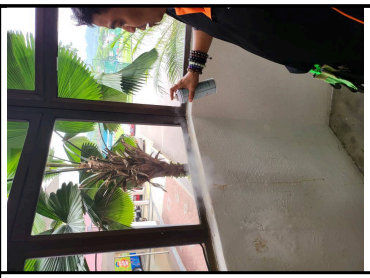
Remarks **Carried out inspection, treatment, search and destroy @ entire school. No sign of s/termite was observed during the time of inspection.**
Found ants @ visitors wating area. treatment done.
Found first and Second stage MOSQ breeding at level 3 water pump tank. Destroy all breeding.
