PRELIMINARY INSPECTION FOR NAVAL BASE PRIMARY SCHOOL – INCLUDING MOE KINDERGARTEN (MK) & KINDERGARTEN CARE (KCARE)

(Preliminary Inspection Report)

Date: 17th December 2021

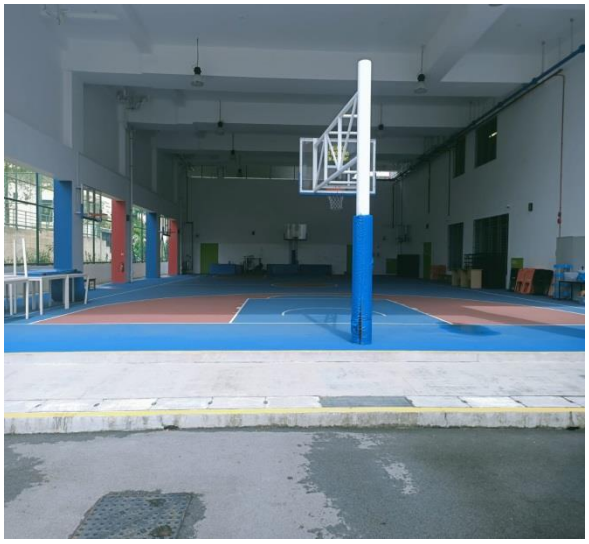
Location: Surrounding sports complex

1) Spotted chocked drains with accumulation of water and sand particles that might become potential mosquitoes breeding.
2) Kindly maintain well the housekeeping and clean up the sand particulars for preventive measures.

Remarks: Heavy stagnation of water caused by uneven gradients detected in Sports Complex perimeter drain. Debris & small rocks also causing water stagnation at said location. Potential breeding ground for mosquitoes

Observation / Recommendations : highly recommended to even the gradients & to clear the drain of debris / rocks to enable flow of water
