PRELIMINARY INSPECTION FOR CHIJ ST NICHOLAS GIRLS SECONDARY SCHOOL

(Preliminary Inspection Report)

Date: 22nd December 2021

Service Report Series Number: 69615

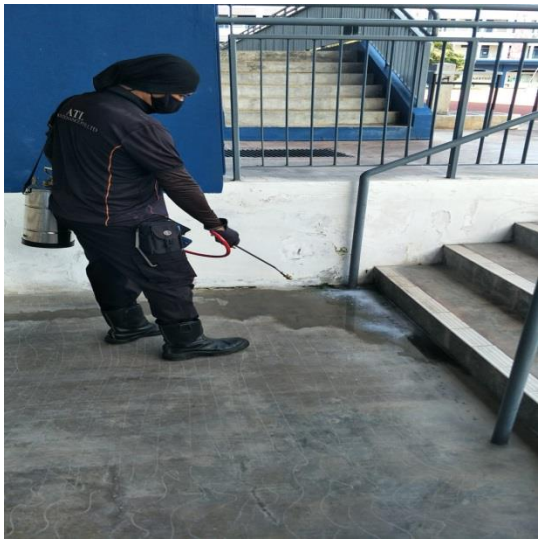
Location: Staircase 17

1) Spotted choked drain that filled with soil that might become potential mosquitoes breeding. No active larva was found during the inspection.
2) Advised to clean up the drain on a regular basis for preventive measure.
